MISCELLANEOUS PAPER CERC-89-5

THE LAKESHORE PARK, ASHTABULA, OHIO, BREAKWATER PROJECT

Coastal Engineering Research Center

April 1989 Final Report

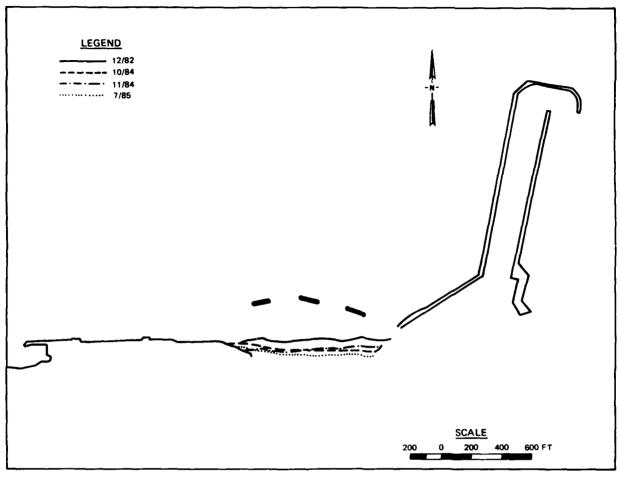
Figure 4. Lakeshore Park aerial shorelines (includes effects of lake levels)

- 13. In order to relate the shoreline changes to a fixed reference, the shorelines from these aerial photographs were digitized and drawn on the same plot (Figure 4). These shorelines have not been corrected for the mean daily lake level, which was generally increasing with each successive aerial photograph. From Figure 4, the continuous retreat of the shoreline is obvious. Between October and November 1984, there is a slight rotation of the shoreline about a point near the center of the beach. This most likely represents a short-term shift in wave direction from the northeast to the northwest. Such short-term reorientations of the shoreline angle within a pocket beach are not unusual. However, this rotation does indicate that the beach was very responsive to the variability in the wave climate despite the protection of the

breakwaters. The most recent shoreline position, July 1985, shows the furthest retreat of the shoreline for the aerial photograph data set. Bathymetry data

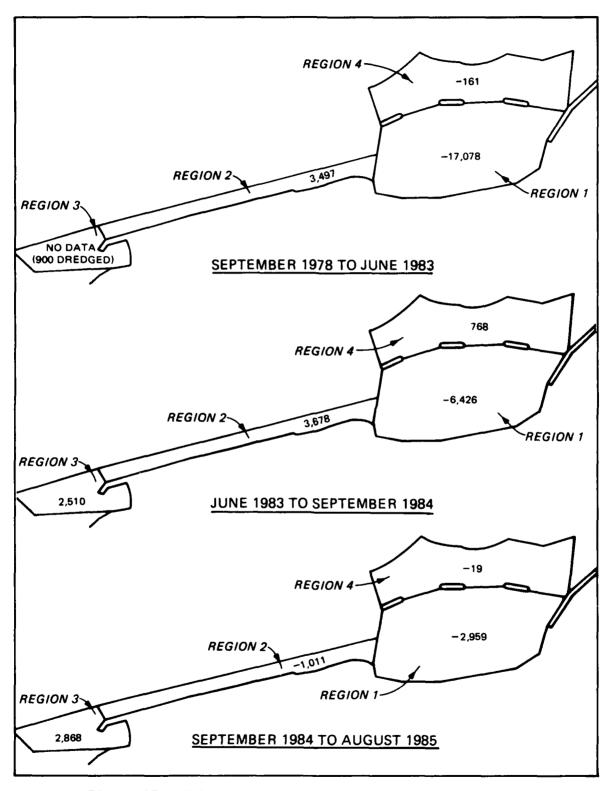
Figure 17. Volume changes in cubic yards for Regions 1-4

18. In order to remove any seasonal changes and possible error in the September 1979 survey, the data for Regions 1-4 were grouped into time spans that generally begin and end in the summer months: September 1978 to June 1983, June 1983 to September 1984, and September 1984 to August 1985. The volume changes for Regions 1, 2, 3, and 4 for these time periods are presented in Figure 17.

19. From the September 1978 to June 1983 time period, Region 1 lost a large quantity of the initially placed beach fill. There is also an increase in Region 2, suggesting that the fill moved from the beach area to the off-shore revetment area. During this time period, 900 cu yd was dredged from the boat launch area (Region 3) and placed on the beach (Region 1). There was a minor loss of material in Region 4 during this time period.

20. The second time period (June 1983 to September 1984) shows a loss of material in Region 1 and an increase of material in Regions 2 and 3. During this period, 1,000 cu yd was dredged from Region 3, and this material was placed on the beach (Region 1). Region 4 gained a slight volume of material during this period. The loss in Region 1 is entirely accounted for by the gains in Regions 2, 3, and 4.

- 21. From September 1984 to August 1985, Regions 1, 2, and 4 lost material while Region 3 gained material. The gain in Region 3 accounts for only 72 percent of the material lost from Regions 1, 2, and 4. Most likely the remainder of the material was lost to the offshore regions.
 - 22. It appears that material was initially lost from Region 1 moving

into Region 2 (and possibly Region 3). Eventually Region 2 began losing material as Region 1, which was supplying the system with littoral material, reached an equilibrium condition. Because the gains and losses in volumes are nearly equal for Regions 1, 2, 3, and 4 for the last two time periods, it appears as if these regions form a near-complete littoral cell.

23. The total volume change from September 1979 to August 1985 for Region 1 indicates that approximately 30 percent of the 37,000 cu yd of placed material remained as of August 1985. Of the quantity that was lost, 60 percent of it can be accounted for the Regions 2-6. Region 2 (boat launch area) received the majority of this material, approximately 25 percent of the quantity lost from Region 1.

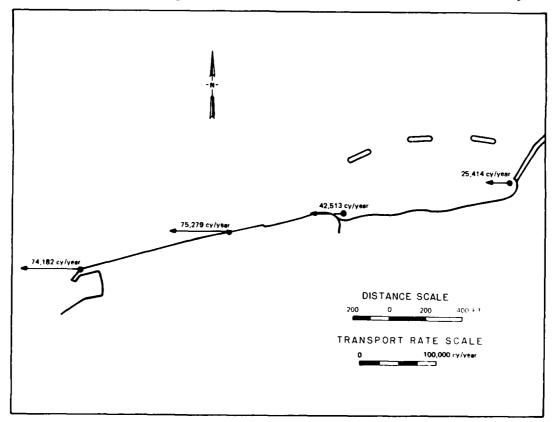
Figure 18. Magnitude and direction of sediment transport from LEO data August-December 1985

24. LEO data were collected from 1 August to 1 December 1985 at four locations at Lakeshore Park. Using the observed wave height, period, and direction data, magnitudes and directions of longshore sediment transport were calculated using Equations 4-38 and 4-50b from the Shore Protection Manual (1984) at each station (Figure 18). All four stations indicate transport from

east to west for this limited period, with the magnitude of potential net transport increasing from approximately 25,000 cu yd/year at the easternmost station to approximately 75,000 cu yd/ year at the two westernmost stations. Gross sediment transport rates are nearly equal to the net transport rates, increasing from approximately 26,000 cu yd/year at the easternmost station to approximately 75,000 cu yd/ year at the two westernmost stations. The near-equality between net and gross sediment transport rates indicates that transport from west to east was negligible during this time period. Although the data set only represents a wave climate from 1 August to 1 December during one particular year, there is a strong indication of westerly transport of material. Perhaps the westerly currents are contributed to by waves reflected off the CEI intake structure or eddies around harbor structures. The predicted LEO transport rates are an order of magnitude greater than the volume changes calculated; the LEO data are probably most useful in a qualitative sense, indicating directions of transport and relative trends between stations.

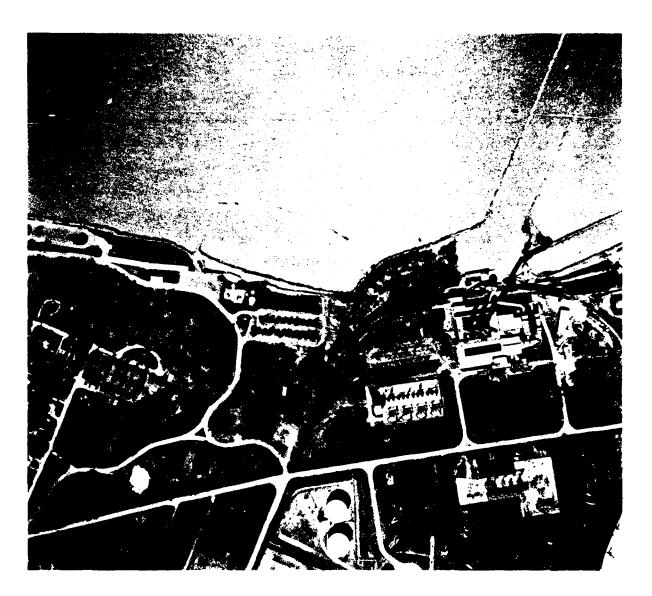
Figure 19. April 1987 controlled aerial photograph showing locations of two groins (scale 1:4800)

25. In August 1986, NCB built a groin at the western end of the beach area in an effort to hold some of the westerly moving material in the beach area. The groin was determined to be the least costly method of reducing sand losses to the west and would pay for itself in reduced renourishment costs in 6 months. The groin is only 150 ft in length, reflecting the assumption that most of the transport is occurring in the nearshore zone. Stone left over from building the west groin was used to build a second groin at the east end of the beach, approximately 50 ft in length. In December 1986, approximately 2,300 cu yd of material with a median grain size of 2.4 mm was placed on the back bluff area to help prevent further erosion of the bluff during winter storms. In May 1987, the material previously placed on the back bluff area was spread onto the beach, and approximately 2,500 cu yd of the 2.4 mm median grain size material was also placed on the beach. The coarser material is expected to be significantly more stable than the original fill. Plans call for 1,000 cu yd from dredging of the boat launch area to be placed on the beach in the summer of 1987. An aerial photograph taken in the spring of 1987 shows the locations of the two groins and the initial beach response to the structures (Figure 19). A site inspection in August 1987 indicated that both

groins are somewhat permeable. However, the western groin does appear to be effective in trapping westward-moving material.
